## 15–503    **Formation of deposits on breaker contact points (contact-controlled transistorized ignition system)**

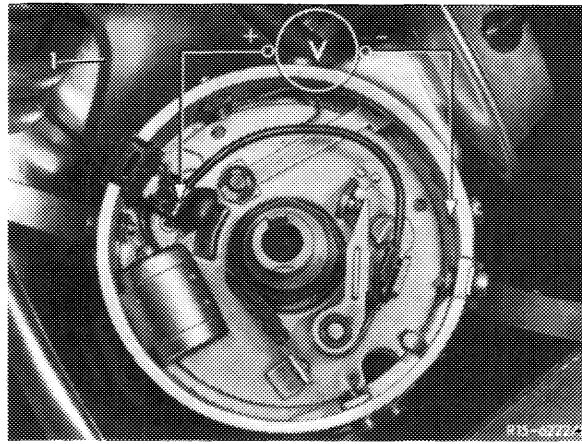
1 Control line with capacitor

Formation of blue or dark-grey deposits on contact breaker points of transistorized ignition system may lead to misfiring by insulating characteristics during progressive stage. Pertinent complaints have resulted in unjustified exchange of switching unit.

Blue deposits (tungsten oxide) are formed by the arc occurring during the dwell stage and the resulting burning of contact material. This arc is caused above all by the discharge of the suppression capacitor installed in ignition distributor.

A large dwell angle (small breaker point gap) favors the intensity of the arc and thereby the formation of deposits.

Dark-grey deposits are caused by burnt grease, oil or dirt particles, formed between breaker points.

1. Deposits on contact breaker points:
  - a) Exchange contact breaker points (refer to repair instructions).
  - b) Remove control line with capacitor and replace by **shielded control line without capacitor**.
2. Score marks on distributor cam or chafed lubrication felt:

Exchange ignition distributor. On new ignition distributor, mount a shielded control line without capacitor prior to installation.
