In the event of complaints about automatic resetting of turnsignal arm, check installation of combination switch on jacket tube and resetting cam on steering shaft prior to installing a new switch.

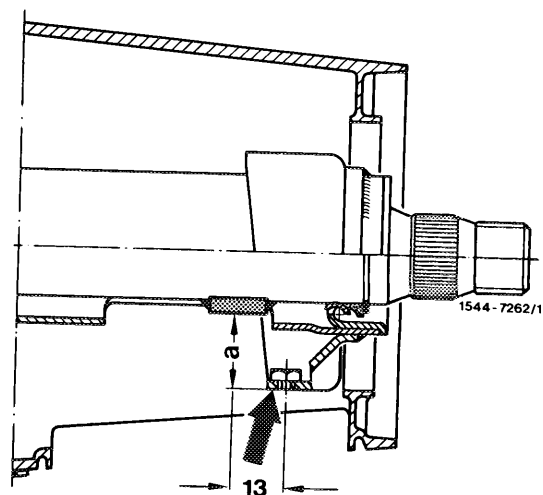
3 Measure dimension "a" at a distance of approx. 13 mm from center of tapped hole (M4) with depth gauge.

Dimension "a" = $20.2^{+0.4}_{-0.2}$ mm

Arrow: contact surface of combination switch

6 Clean contact surface (arrow) of combination switch on jacket tube from remaining paint, remove burr if required, and refinish contact surface carefully with a file, if required, until the required distance has been established.

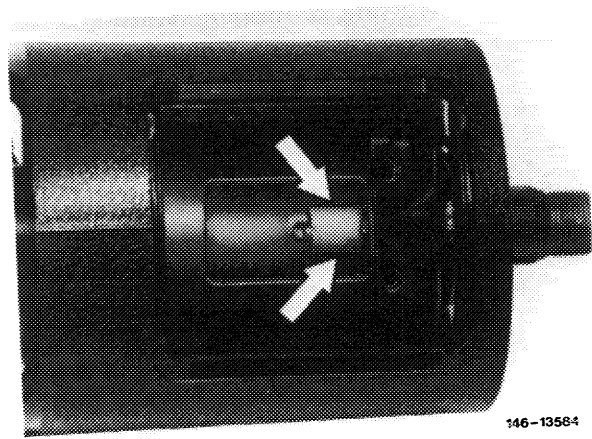
7 If traces of wear are showing up on resetting tongue of combination switch, check radii of resetting cam on steering shaft. If the resetting cam is sharp-edged on resetting surfaces, the resetting tongue of combination switch will be worn out.

8 Refinish sharp-edged resetting cam e.g. with a conventional grinding point (diameter approx. 6 mm) until a radius of approx. 0.8 mm is attained (arrows).
