Three-point belt with inertia reel

made by Klippan

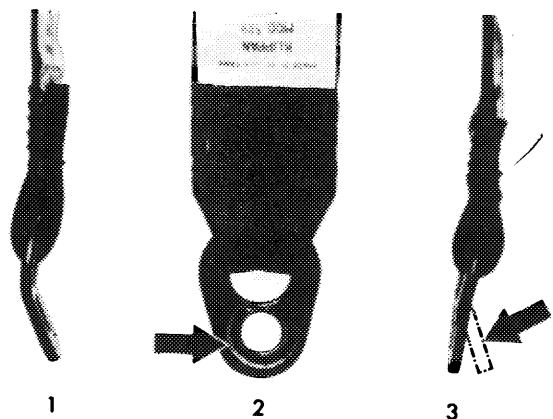
191-10606

Belt end fitting is deformed, that is, the formerly off-set end is now straight.

Belt end fitting is damaged by fastening screws (arrow).

In addition, the plastic coating of the lock catch may show chafe marks and there may be bright spots at belt in range of belt guide fitting and catch.

- 1 Belt end fitting undamaged
- 2 Belt end fitting damaged
- 3 Belt end fitting deformed during an accident

In the event of an accident at a front impact speed of more than approx. 30 km/h, the belt end fitting of the safety belts will be damaged. In such a case, replace safety belt.
