All models

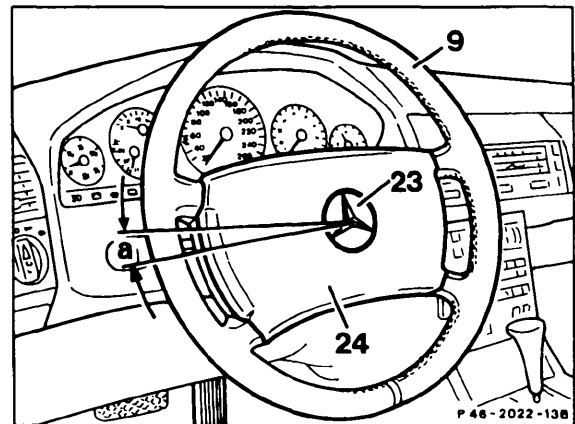
a = max. 25 mm

- In steering center position, maximum allowable play (a) at steering wheel is 25 mm.

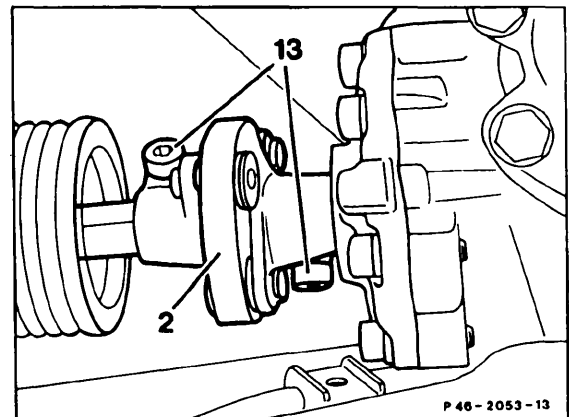
Models 124 (except 124.034/036), 129, 201

- On all models starting 04/1984, check play of steering coupling or of both flexible couplings (2).

2 Flexible coupling

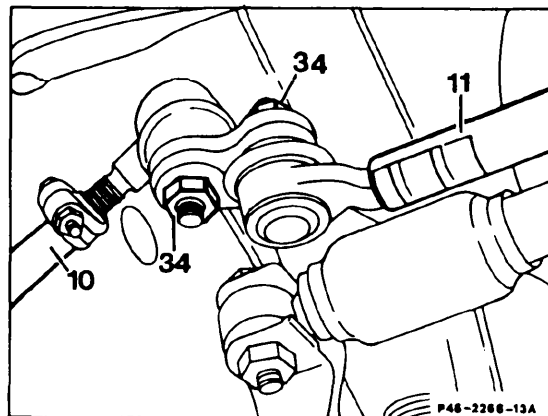
- With vehicle resting on wheels, move steering left and right approx. 100 mm while checking the following ball joints:
- Tie rod end (10) ball joints.
- Tie rod (11) ball joints.
- If play is found, replace the appropriate ball joint.
- Check condition of rubber boots.

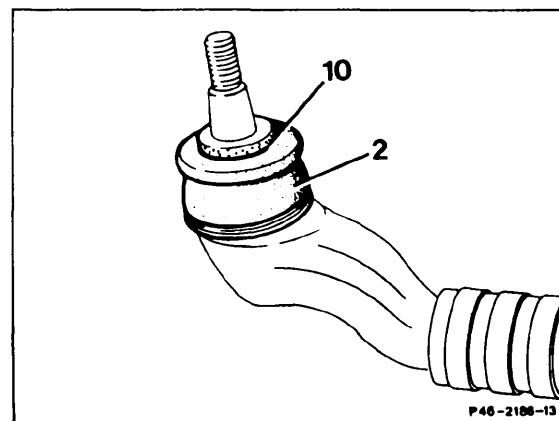
2 Rubber boot

If a damaged rubber or plastic boot is found, replace affected joint immediately, since penetrating dirt will destroy joint in a short time. **Replacement of only the boot is permitted only if no dirt whatsoever has entered the joint.**
